CASE STUDY

A pre-2000 PET Bottling Line Main Gearbox/ Pinion Bearing

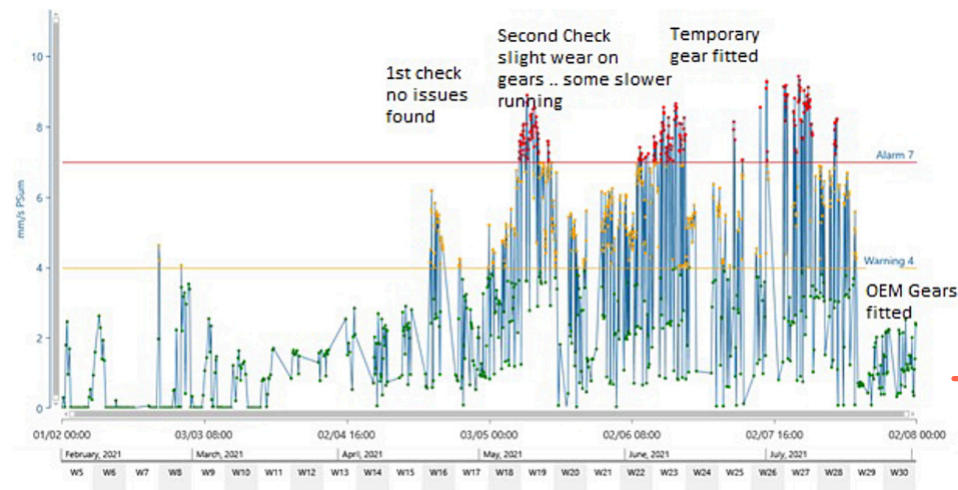
Figure 1
- GBX O/P ISO
velocity trend

Initially, the velocity levels on the main gearbox output increased from typically 2mm/s to exceed 5mm/s in early April 2021 (as seen in Figure 1). The site engineers were informed and asked to check for any looseness or signs of low lube as is normal in this type of increase. Engineering feedback stated there was no looseness and the gearbox oil levels were correct; an oil sample analysis showed no obvious wear particles.

The levels increased again fast through July (using the temporary printed gears) - as you can see from Figure 1; after the OEM gears were fitted in early August 2021, the levels dropped to pre-fault velocity levels of around 2mm/s RMS.

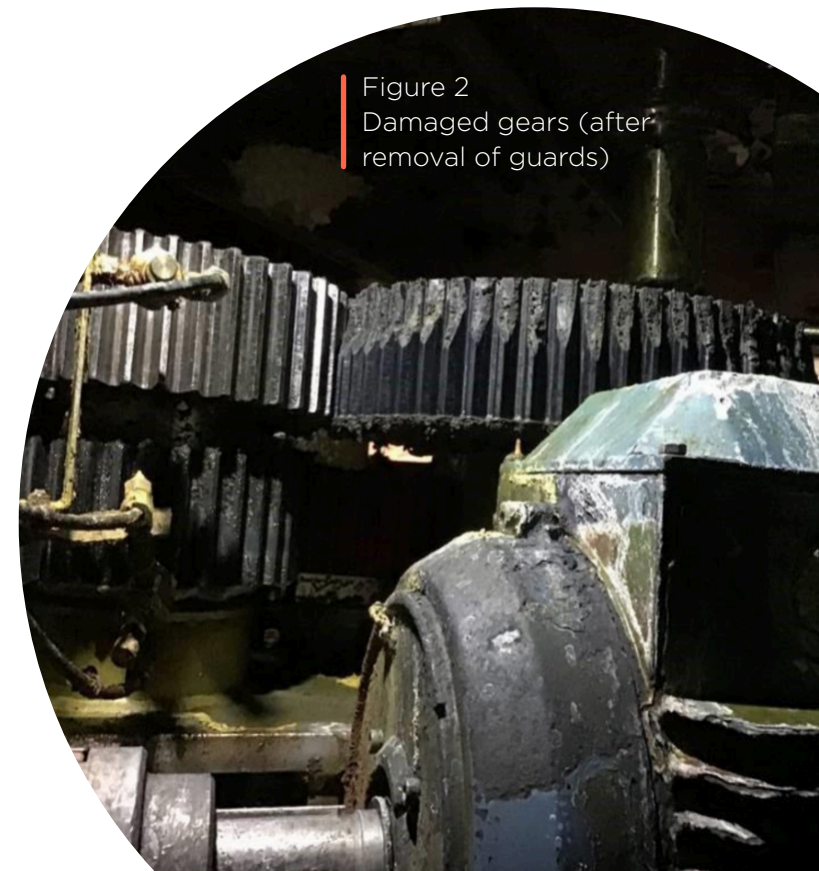
The levels increased again through May 2021 and a more detailed inspection showed gear wear - (see Figure 2, picture of damage). DIAGSOL engineers looked at the raw FFT and time domain data and multiple gear-mesh harmonics were dominant. The OEM gear set was 10-week delivery; hence the site engineers had a pair of gears printed as a temporary measure; these were fitted two weeks later.

Figure 2
Damaged gears (after
removal of guards)
